マモリア mamoria

— エルファ —
elpha

BIOFILM REMOVAL

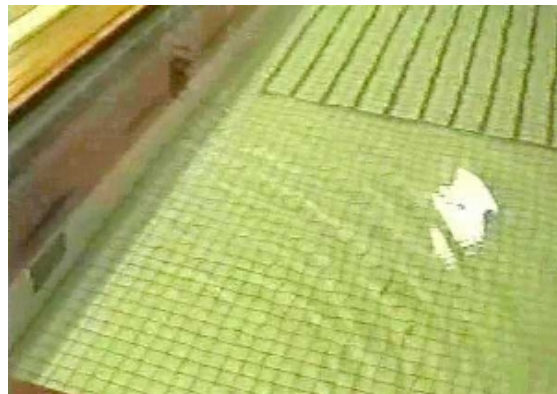
After 6 days, the pool was clean

Upon conversion to mixed oxidants, sloughing was immediately apparent as particles of biofilm began to appear on the pool surface. Operators manually removed the biofilm and within one week of operation, the pool water was clear.

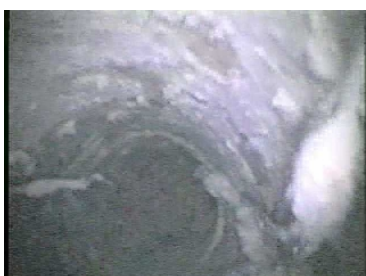
FEED WATER PIPE

*Feed water pipe with
sodium hypochlorite*

Even more impressive was the videotape showing biofilm removal in the 4-inch pipelines. In the feed water pipe, substantial removal was evident after 6 days, and during the last videotaping at

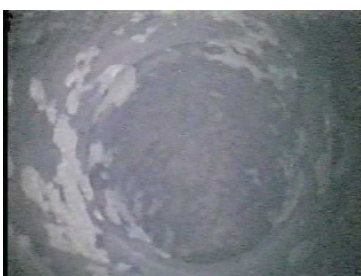
*After 6 days with
mixed oxidants*

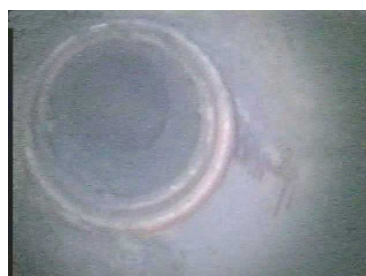
*After 22 days with
mixed oxidants*

22 days, removal of biofilms was total. The same phenomenon occurred in the filter recirculation pipe with the entire filamentous mass completely eliminated.

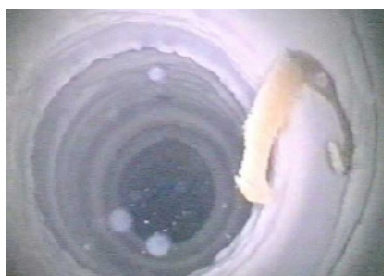
FILTER RECIRCULATION PIPE

With sodium hypochlorite

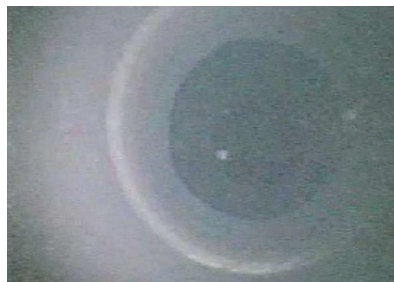
With mixed oxidants

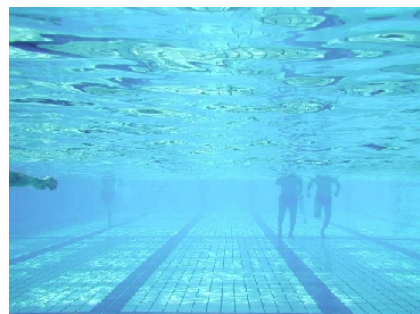
With mixed oxidants

Installations at Shibasaki Gymnasium in Tachikawa City and Miwa Town in the Aichi Prefecture of Japan, both initially using sodium hypochlorite disinfection, reported drastically improved clarity of the water after only 4-5 days of operation with MIOX mixed oxidants. Improved water clarity indicates a removal of biofilm contamination and/or algae growth responsible for the cloudiness in the water.

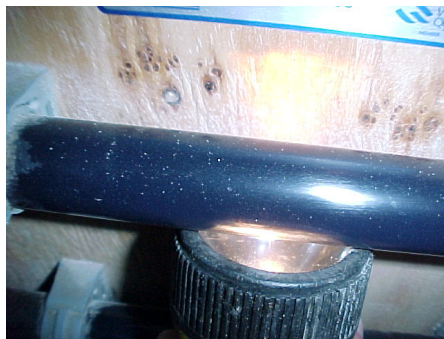
Black biofilm coating before application of mixed oxidants

In an unrelated study, Charles Smith of Quality Water Systems installed a small MIOX system on a bakery cooling tower for a pilot test.⁶ Upon start of the test, the clear pipelines were completely obscured by a “leathery” black slime. Previous disinfection with hypochlorite had minimal impact on the biofilm contamination, and the pipes required cleaning within 10 days after disinfection was stopped. In contrast, mixed oxidants thoroughly broke down the biofilm. When the MIOX pilot system was removed, the bakery owners reported that it took 3 weeks for the biogrowth to reform, and even at that point, the “leathery” texture was not apparent, so cleaning was unnecessary. Mixed oxidants removed even the tough substrate that allows more rapid regrowth of biofilm.

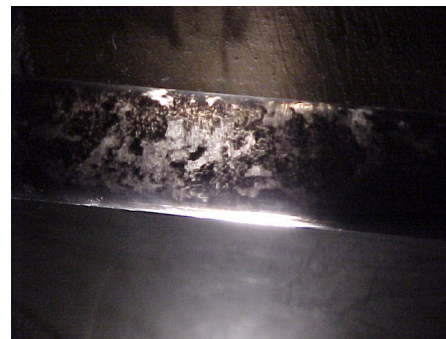
Breakdown of biofilm begins with mixed oxidants

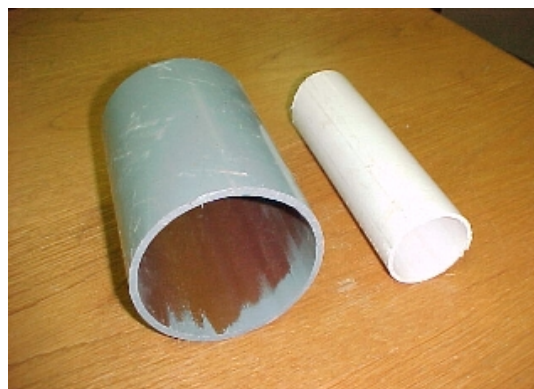
Biofilm contamination on chlorine-treated line (left) versus mixed-oxidant line (right) at Diana Water Supply

Diana Water Supply in Texas has a number of well sites and has been gradually converting from chlorine gas disinfection to MIOX mixed-oxidant generation, beginning in 1996. Several years ago, two line breaks occurred around the same time, one on a line treated with chlorine gas and the other on a line treated with mixed oxidants. Both pipelines had been in use for more than ten years, and both were originally on chlorine gas. The conversion to mixed oxidants on the second line had taken place about one year prior to the line break. The chlorine treated

line was only 200 feet from the disinfection station, yet it was coated with a brown slimy substance. In contrast, the mixed-oxidant treated line was half a mile from the disinfection station, but the line was completely clean.
